Service bulletin

No.: G304S – 15 a)

TC(s) no.: EASA.A.030
Model(s): Glasflügel 304MS

Modification of starter power cables

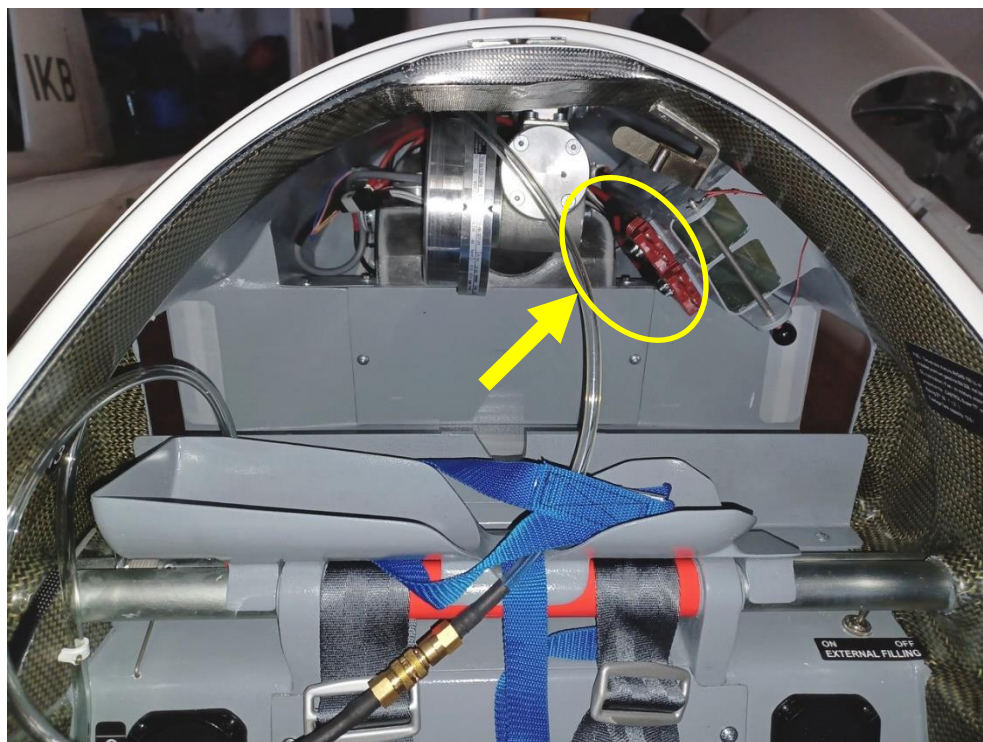
Fig. 1 – Starter battery connectors in the luggage compartment area behind the pilot's headrest

The battery holders are located on the left side of the luggage compartments behind the pilot's headrest (see Fig. 1).

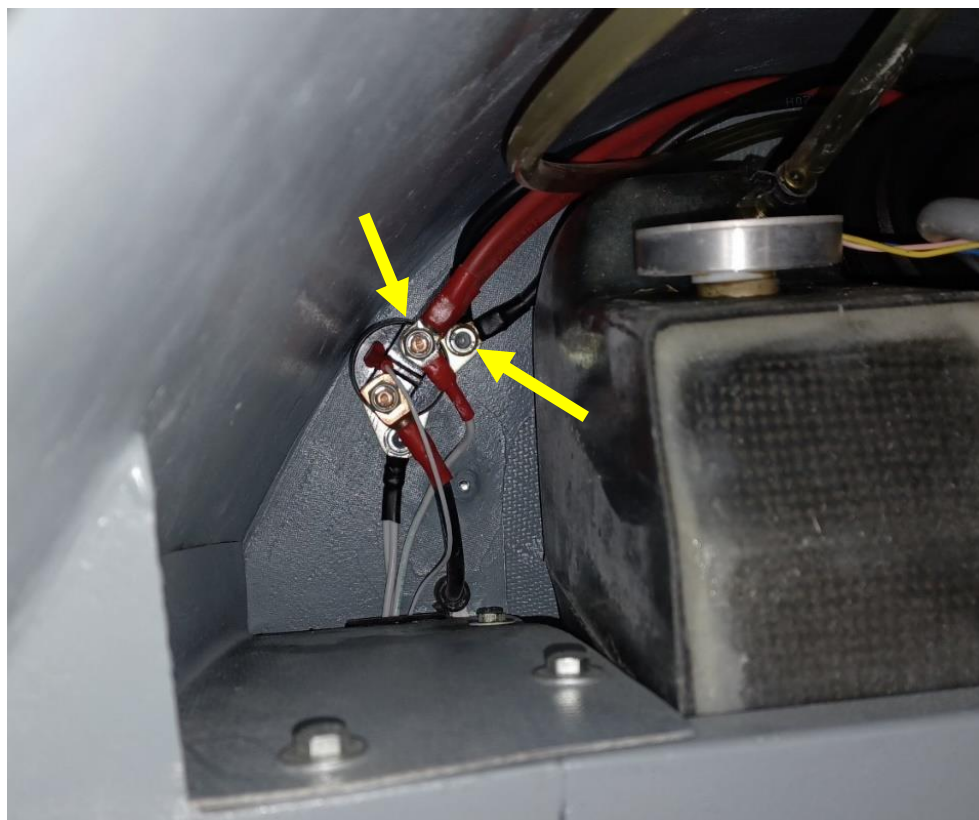
Fig. 2 – Starter relay, battery cable ends to be disconnected marked by arrows

- 1) Remove both starter batteries out of the holders. Store them securely.
- 2) Disconnect avionic power sources.
- 3) Check that both the main switch and engine main switch are off.
- 4) Disconnect the battery cables from the starter relay.
The relay is located on the right side of the rear luggage compartment wall (see Fig. 2).

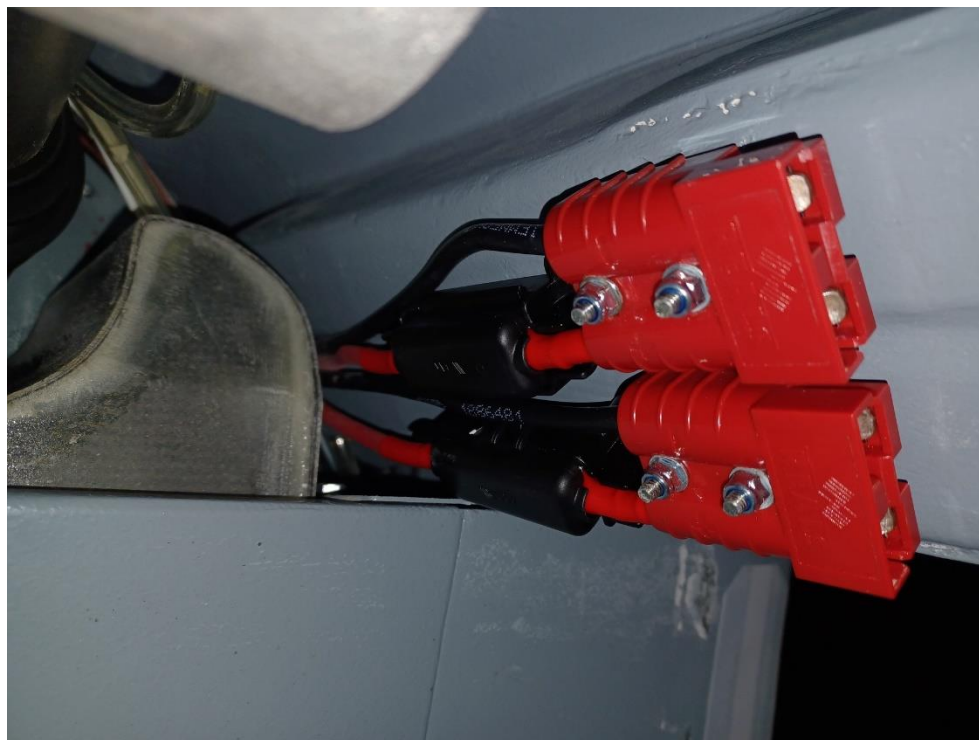
Check if fuse boxes are present as shown in Fig. 3. If not, replace the cables for both starter batteries with new cables with pre-installed 80A fuses as follows.

Fig. 3 – Replacement cable after installation.

- 5) Remove the battery connectors on the other end of the cables from the battery holder, carefully pull the cables out
- 6) Replicate the routing of the original cables with the new cables, then attach on the relay end (see Fig. 2 for end result)
- 7) Attach the battery connectors back in their original positions. The fuse covers shall have their bases aligned to the battery holder, but are not otherwise secured – see Fig. 3.
- 8) Check the system function.

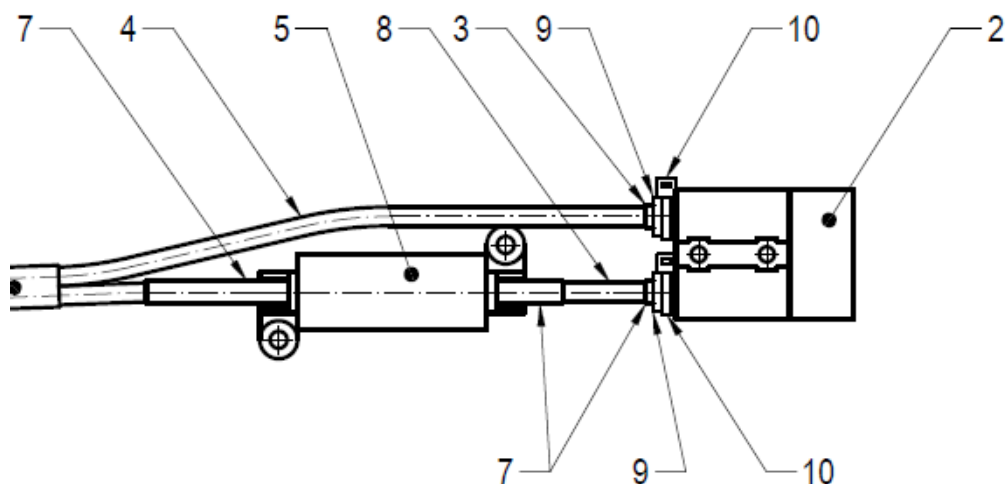
Check if inserts (see Fig. 4 pos. 9) are present. If not, proceed with modification of the connector terminal through the inserts to limit the cable movement and assuring proper terminal position.

Fig. 4 – Assembly of starter battery connector:

Connector (2) with connector inserts 304S-82-90 (9);

secured by cable ties (10); shrink tube – black (3) and red (7)

- 1) Open the 304S-82-90 insert and position its grooved end for the tie wrap away from the connector.
- 2) Close the insert, then secure it lightly with a tie wrap.
- 3) Slide the connector insert into the connector opening along the cable until the tie wrap touches the connector end. Fasten the tie wrap firmly and adjust its free end.
- 4) Repeat this procedure for all individual cables entering both starter battery connectors.
