Service bulletin

No.: G304eS – 14a)

Type Certificate No.: EASA.A.030
Model: Glasfögel 304eS
Serial No.: all

FES system wiring – inspection / replacement of shunt cable attachment screws

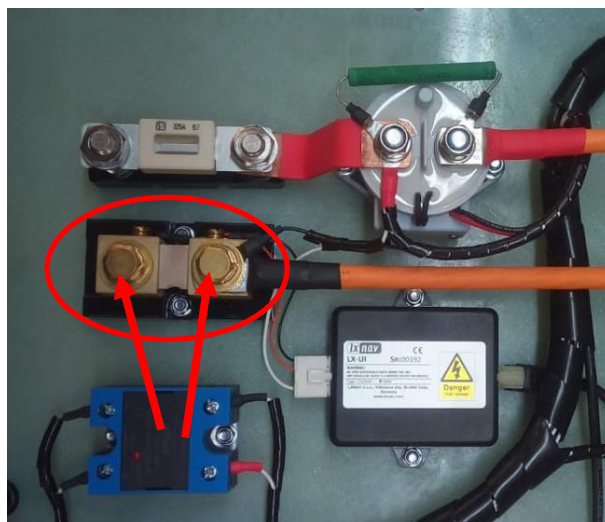
A shunt (resistor) circuit is used to measure voltage drop (and thus calculate current from the batteries). This shunt is connected to the negative pole of the battery packs and the motor controllers, respectively, using high current cables. These cables are attached to the shunt circuit using brass screws (see Figure 1).

Based on reports of the similar FES system installations where these screws heads were found torn off. To make the connection more robust and reliable, the brass screws are replaced by steel screws.

This condition, if not detected and corrected, could lead to FES loss in flight.

Figure 1 – Detail of shunt circuit (encircled, with screws marked with arrows)

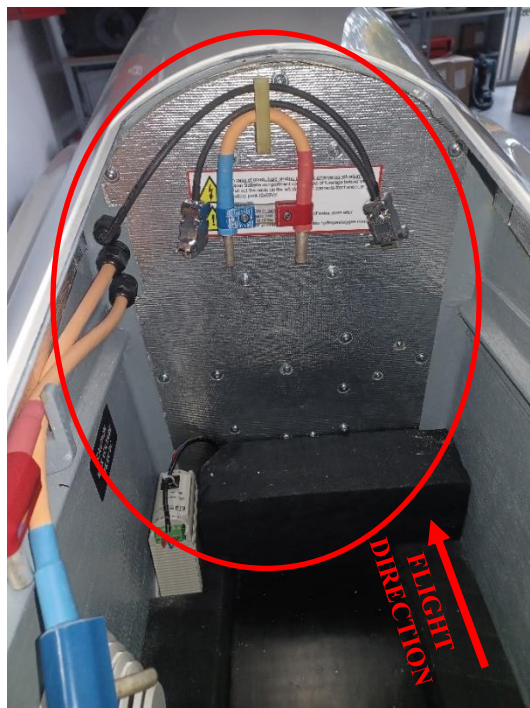
The shunt circuit is located on the front side of the firewall (see Figure 2).

Figure 2 – Firewall, the shunt circuit is located on its front side

Demount the firewall.

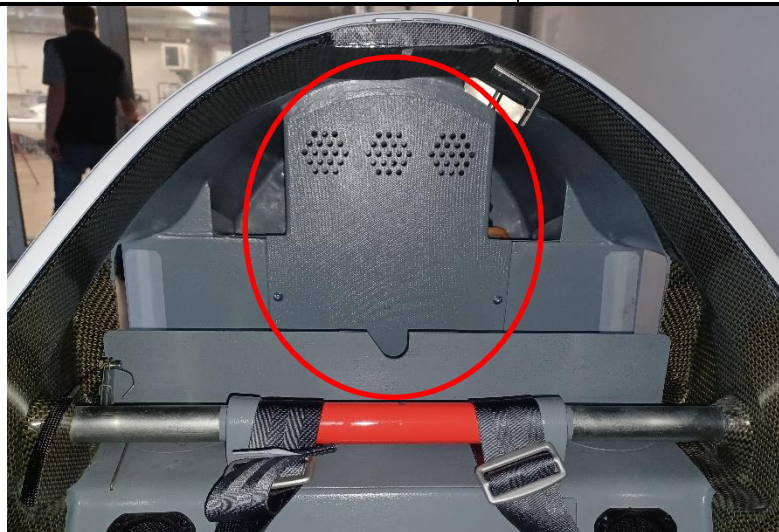
Figure 3 – Engine controller cover in the rear of the luggage compartment

In order to do so, the battery packs and the floor pads must be removed from the battery compartment, the shunt circuit cables leading to the engine controller must be disconnected from the controller (accessible through controller cover in the rear of the luggage compartment, see Figure 3), the firewall securing screws must be removed and the whole firewall assembly with shunt circuit carefully pulled out and laid onto battery compartment floor. The procedure is described in detail in the Working Instructions.

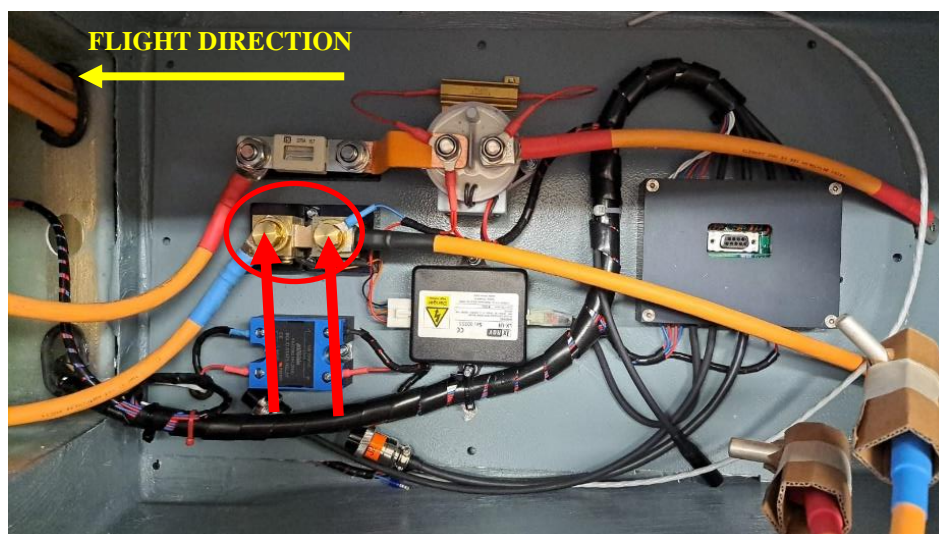
Inspect the shunt circuit, note screw type and condition (see Figure 4).

Figure 4 – Disassembled firewall laid on the battery compartment floor, with shunt circuit screws marked by red arrows.

If steel screws are used, no replacement is necessary, and the firewall, any connections and covers are reattached according to the Working Instructions. If brass screws are used, Action 2 shall be accomplished.

Remove the brass screws (see Figure 4) and their washers.

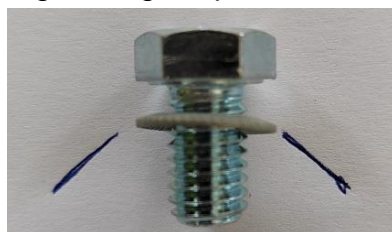
Figure 5 – Proper orientation of “Schnorr” safety washer

Install replacement steel screws and safety washers, ensure the correct orientation of the safety washer (see Figure 5).

In addition to safety washer a thread locking adhesive (medium strength – Loctite 243 or similar) should be used on the screw thread.

Tightening torque is 17Nm.
